4. TITLE (and Subtitle) Foundation report, Supplement Unit 2 (Part 1) Pigeon Creek Three Pump Stations, Evansville, IN.		5. TYPE OF REPORT & PERIOD COVERED Final

This report supplements the prior foundation report on the Evansville, IN, levee. It covers foundation conditions encountered and methods of constructing three pump stations within those conditions.

Foundation Report
Supplement No. 2 Volume II
Evansville, Indiana
Local Flood Protection Project
Pigeon Creek Section
Unit 2 (Part I) Pump Stations
Sixth Ave., Dresden St., Delaware St.

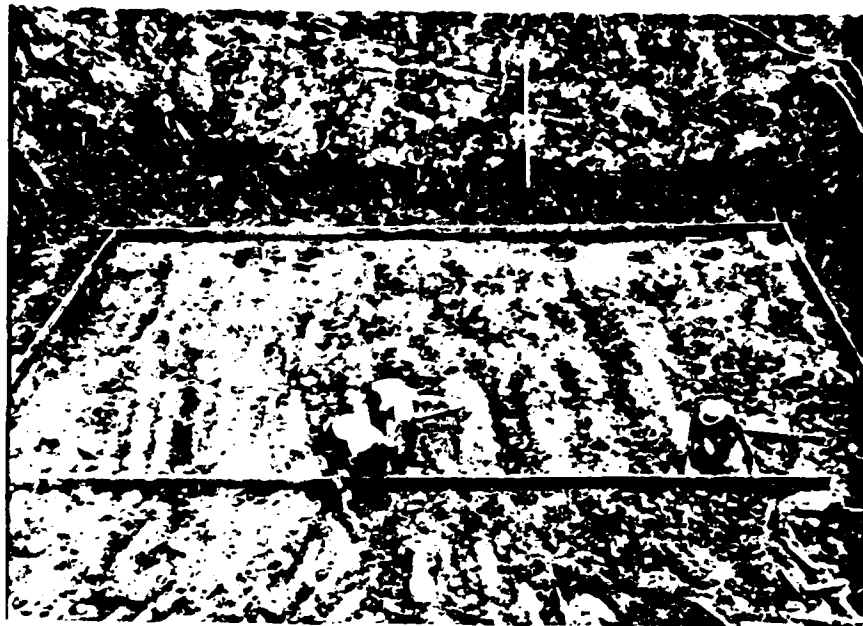
Sixth Avenue Pump Station Foundation - View East

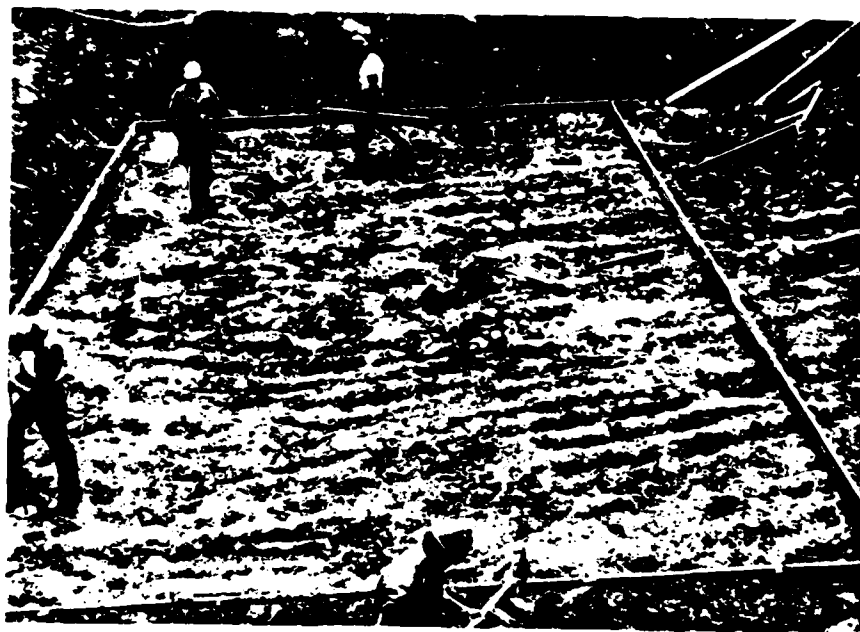
Sixth Avenue Pump Station Foundation - View South

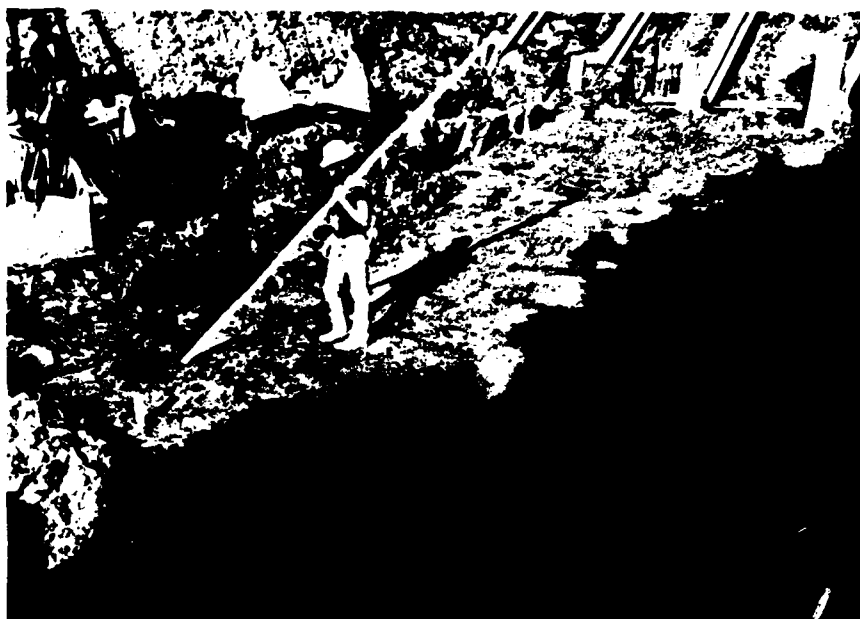
Northern Half of Foundation

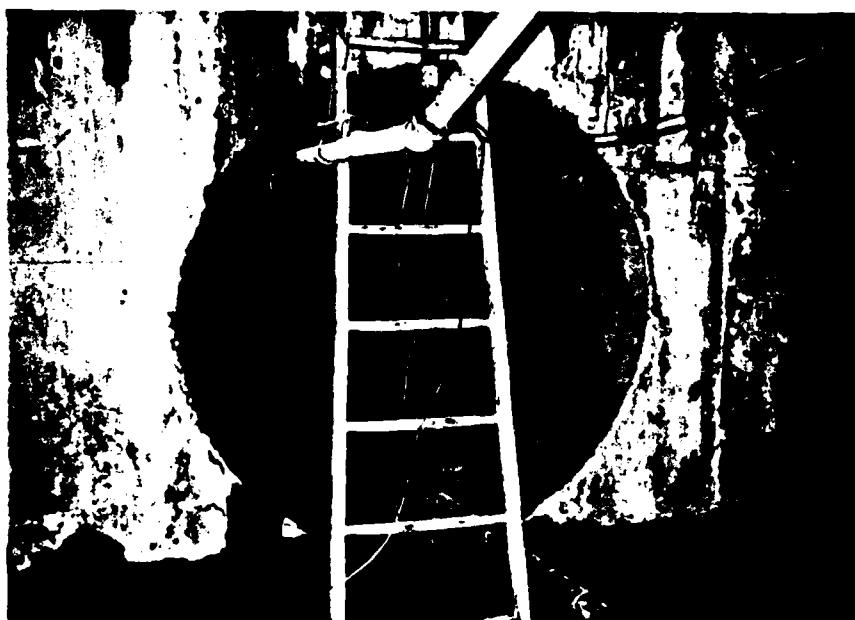
6-01 72" Influent Pipe - Delaware Street. Sometime in mid October 1981, 72-inch entrance pipe was discovered to have settled. The most obvious failure was the first joint outside the structure wall. There was approximately a 2-inch offset between the two sections at this joint. A subsequent profile of the pipe invert indicated that the lowest point was actually at the connecting collar between the existing pipe and three sections of new pipe used to connect to the structure. There did not appear to be any serious cracking or pipe failure in any joint except the first one outside the building structure. This was due to the fact that some 2 feet-5 inches of the first section of pipe is embedded in the structure wall and, therefore, could not flex. After monitoring the pipe for nearly two months, it did not appear that any more movement was taking place. There was a constant flow of water through the pipe joints that increased and decreased as the river elevation changed. Engineering Division decided the most economical repair would be to insert a 28 foot long, 66-inch diameter, 3/8-inch thick steel pipe inside the 72-inch pipe and fill the annular space with non-shrink grout. A change order was given to Indiana Construction Company to do the work. They engaged Penetryn System, Inc. from Knoxville, Tennessee to stop the flow of water through the joints by injecting a gel sealer. After this work was successfully completed, Deig Brothers Construction Company subcontracted the installation and grouting of the steel pipe. The steel pipe had to be cut into four pieces and then rewelded in the sump area due to the limiting size of the access hatch. The annular space was filled by pumping approximately 5 yards of 12 bag sand, cement

72" R.C.P. with 66" Steel Liner Installed
